Sample Grouted Cell Report

Qualitative Infrared Thermographic Survey of Masonry Walls

Sample Retail Store

**PROJECT: Sample Retail Store
Your Town, USA.**

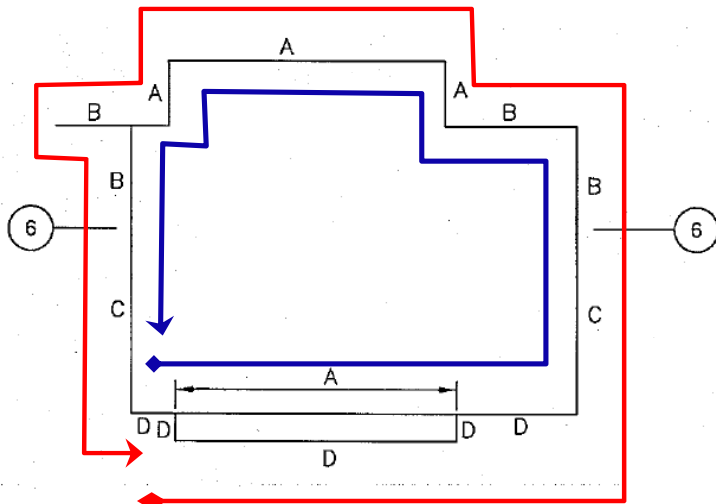
ATTACHMENT A - DRAWING

DIRECTION OF SURVEY

- Outside
- Inside

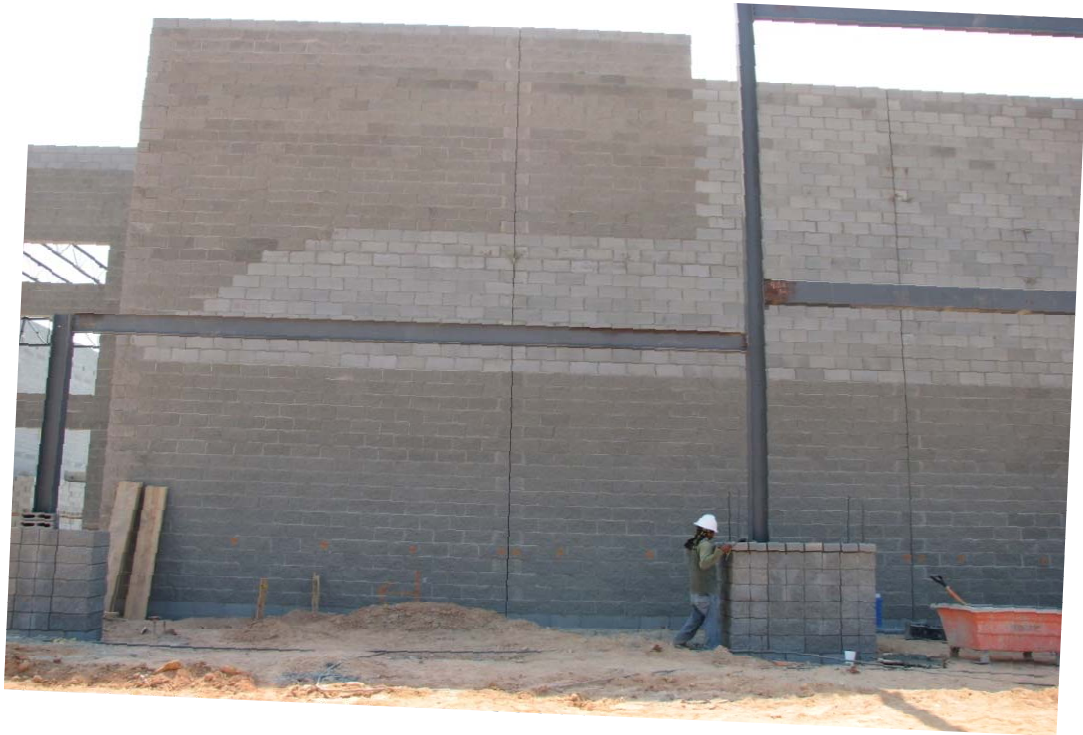
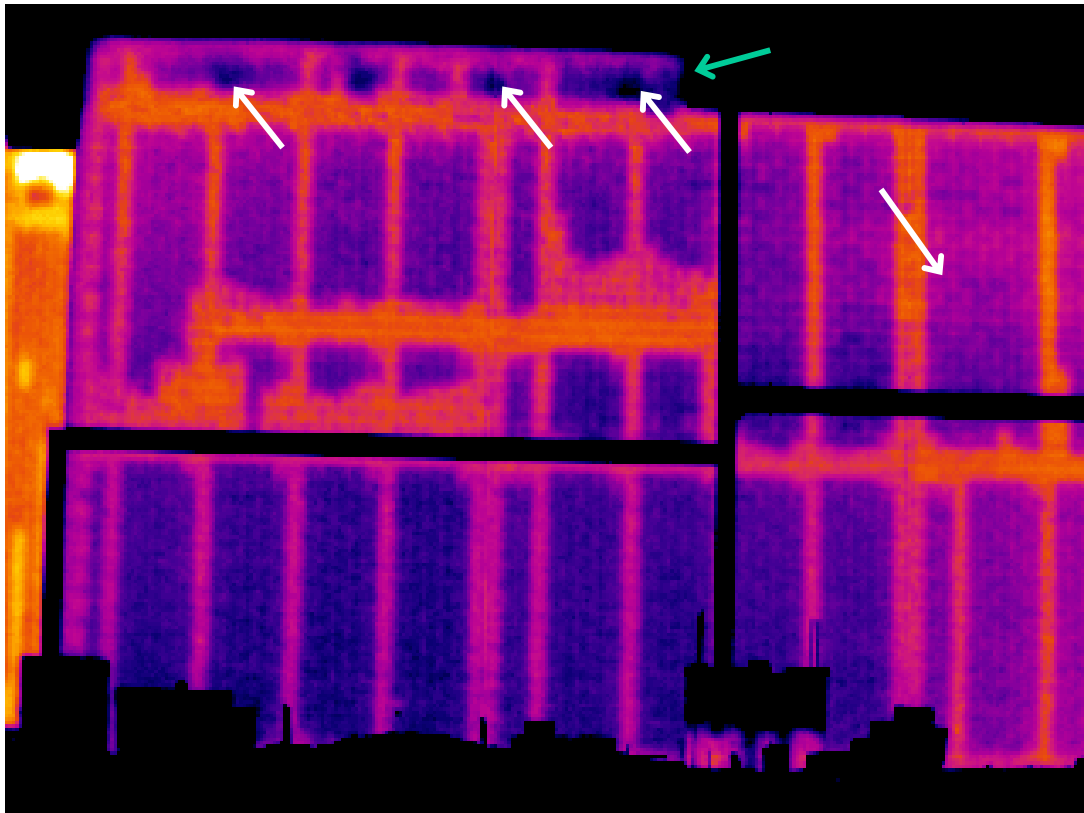
THERMOGRAPHIC REPORT # 1

Down Column Line 1
From Column J.30 to H.24
Description Grouted cells as indicated.

Solid areas are light-colored.
Grouted cells 48" O.C.
Structural Grouting Schedule

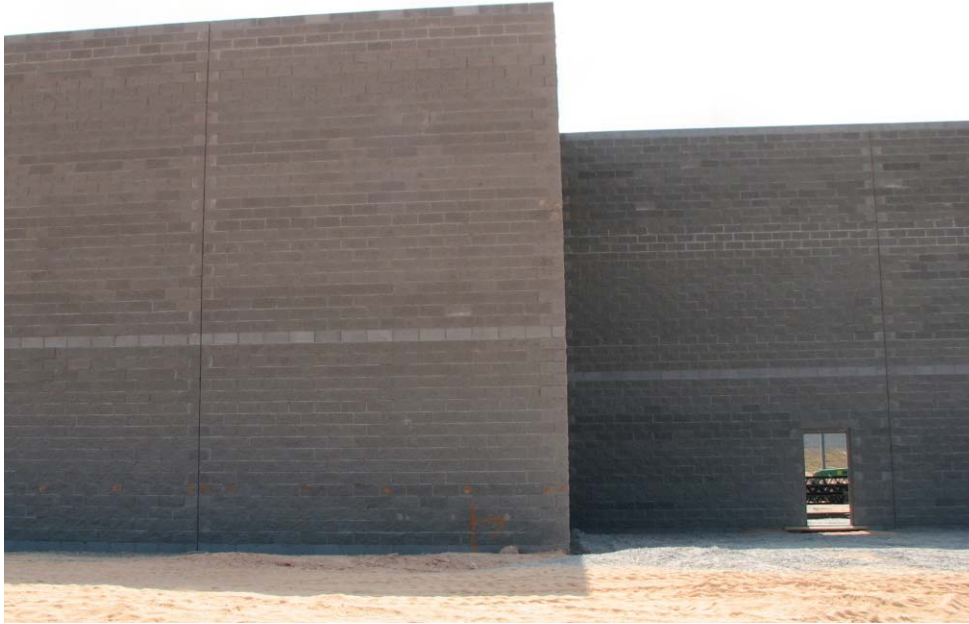
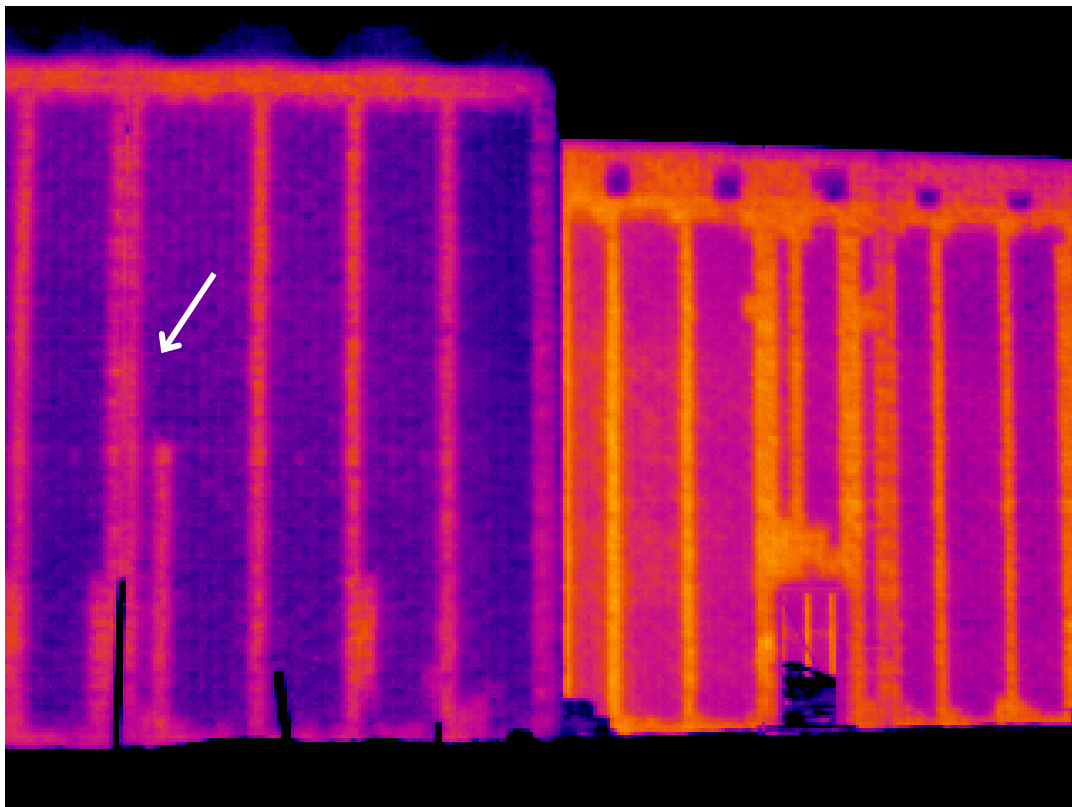
THERMOGRAPHIC REPORT # 2

Down Column Line 2
From Column D to C.16
Description Grouted cells as indicated.

Solid areas are light-colored.
Grouted cells 48" O.C.
Structural Grouting Schedule

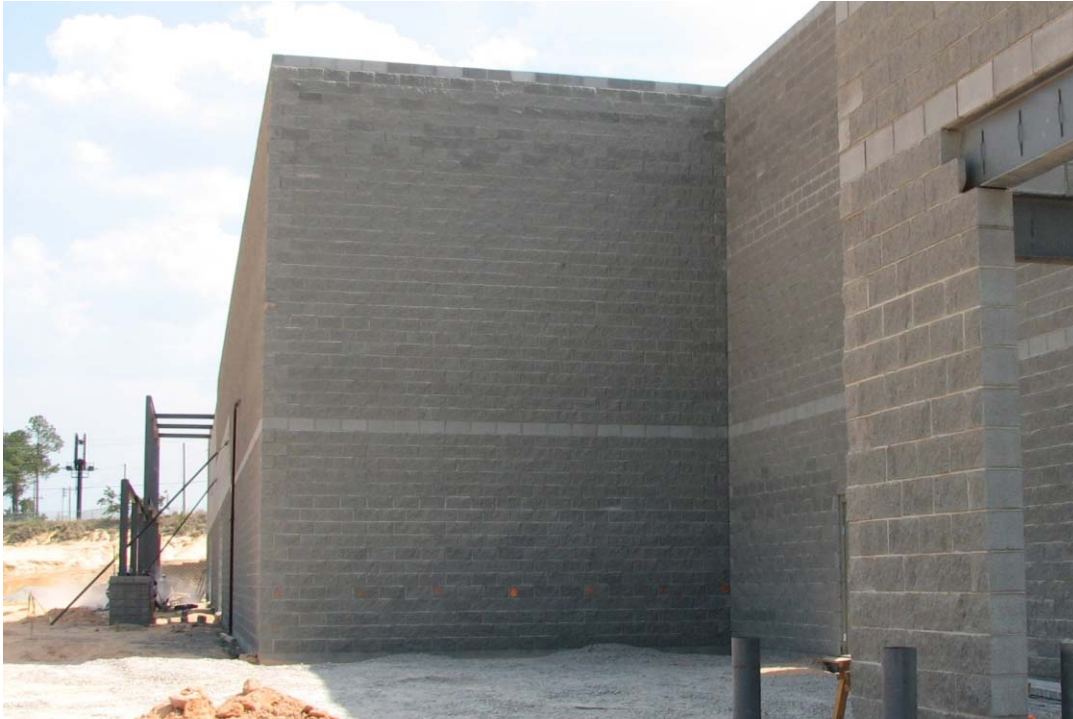
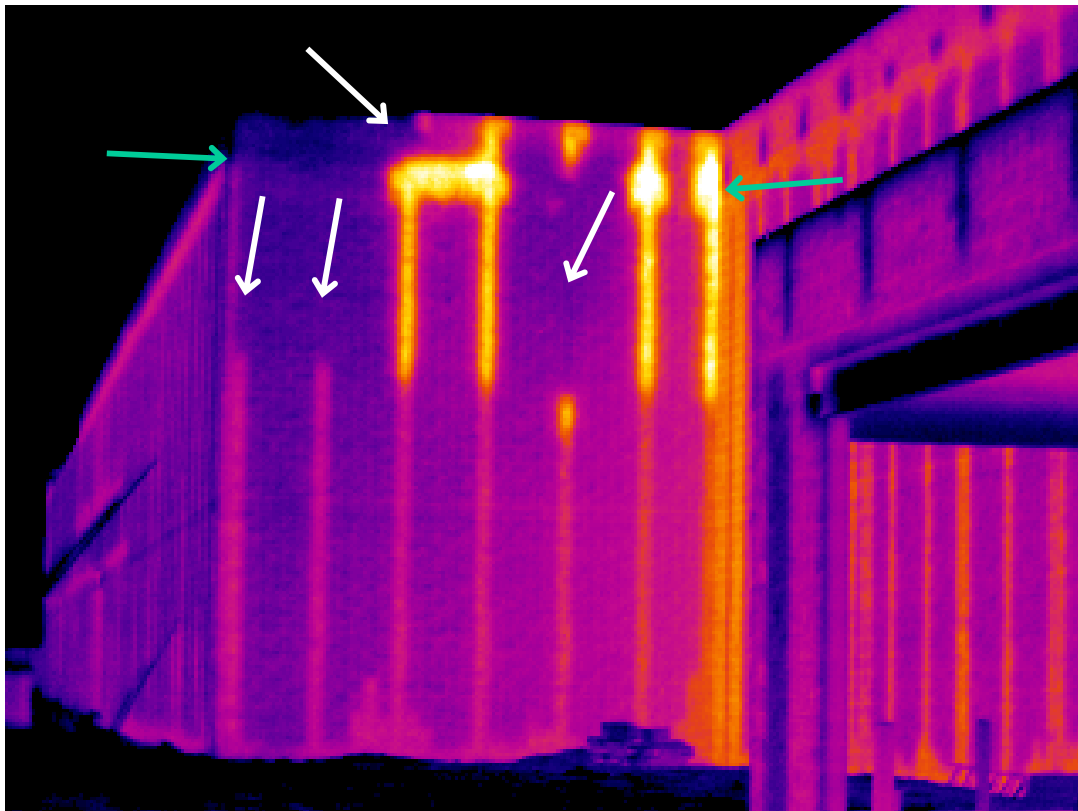
THERMOGRAPHIC REPORT # 3

Down Column Line C.16
From Column 1 to 2
Description Grouted cells as indicated.

Solid areas are light-colored.
Grouted cells 48" O.C.
Structural Grouting Schedule

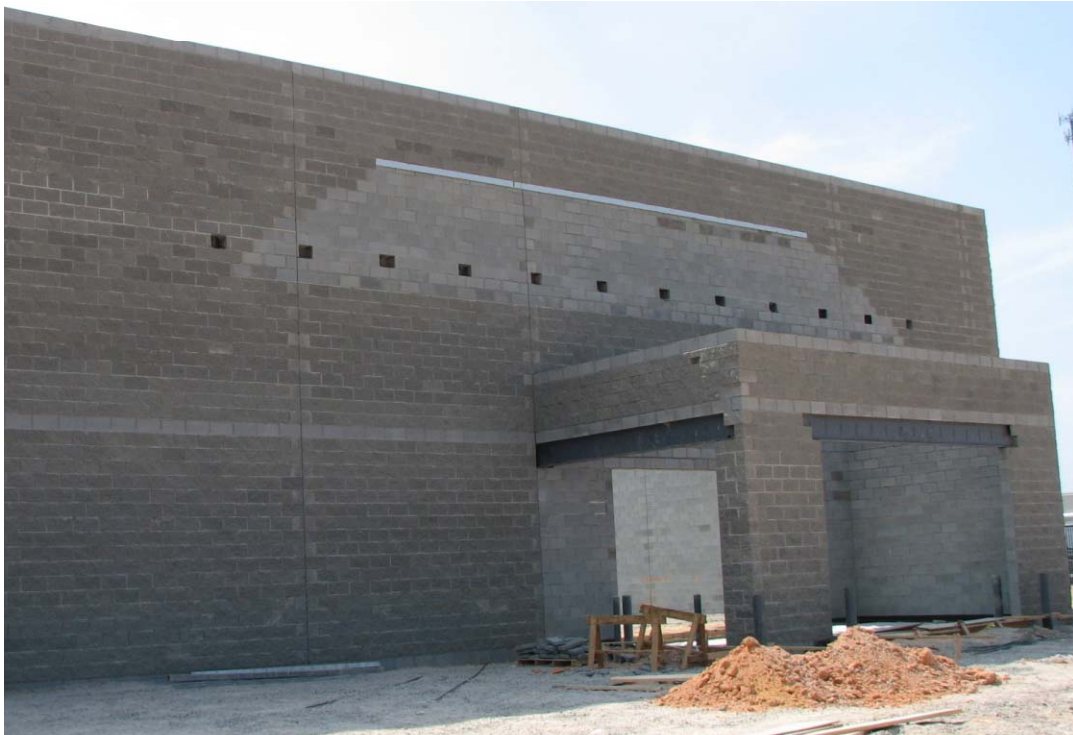
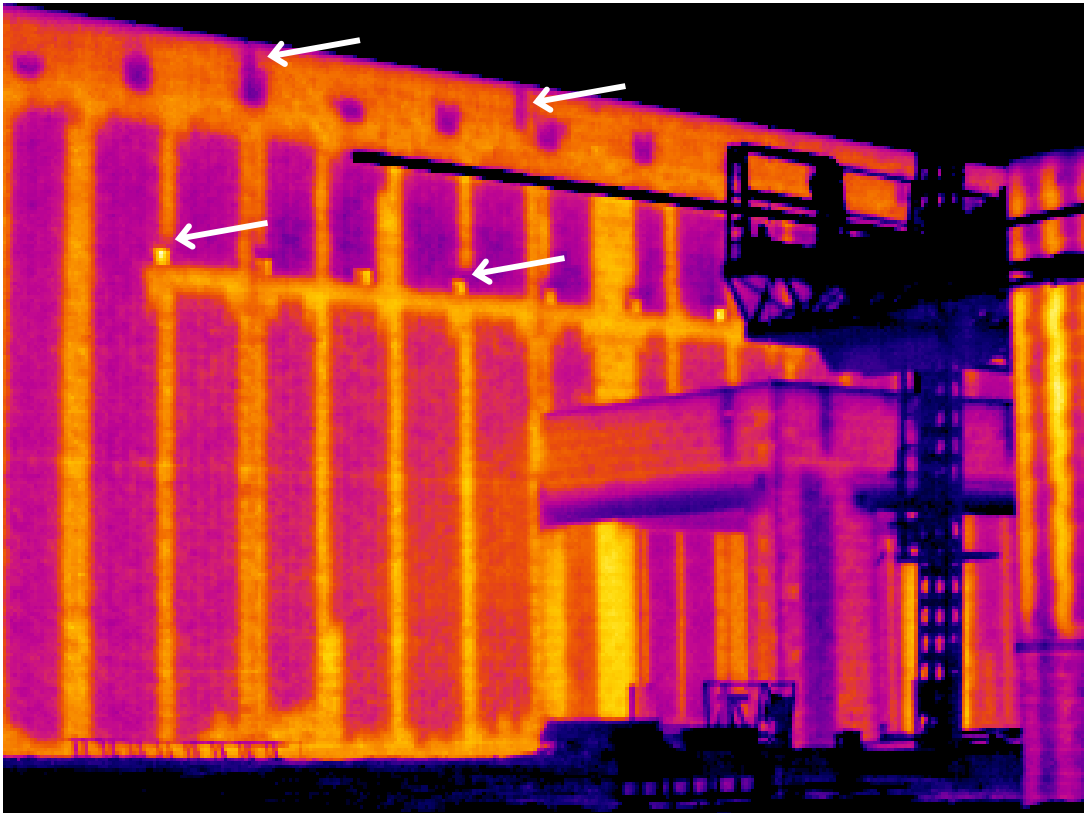
THERMOGRAPHIC REPORT # 4

Down Column Line 2
From Column C to B
Description Grouted cells as indicated.

Solid areas are light-colored.
Grouted cells 48" O.C.
Structural Grouting Schedule

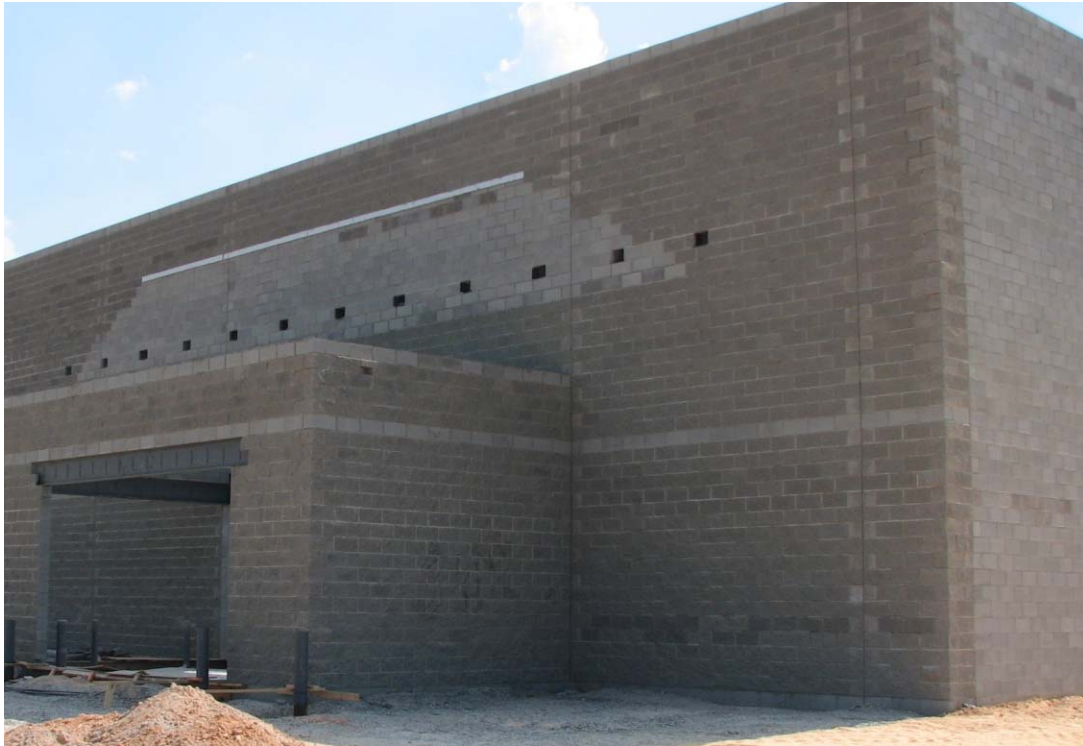
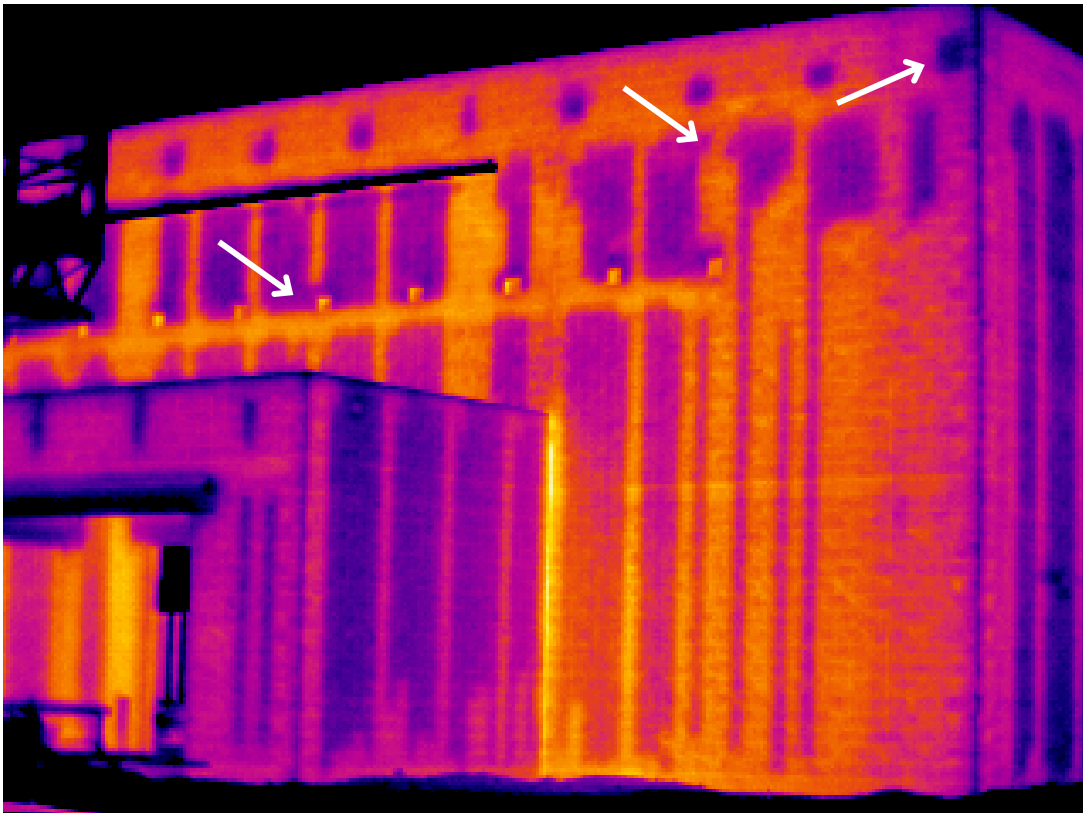
THERMOGRAPHIC REPORT # 5

Down Column Line 2
From Column B to A
Description Grouted cells as indicated.

Solid areas are light-colored.

Grouted cells 48" O.C.
Structural Grouting Schedule

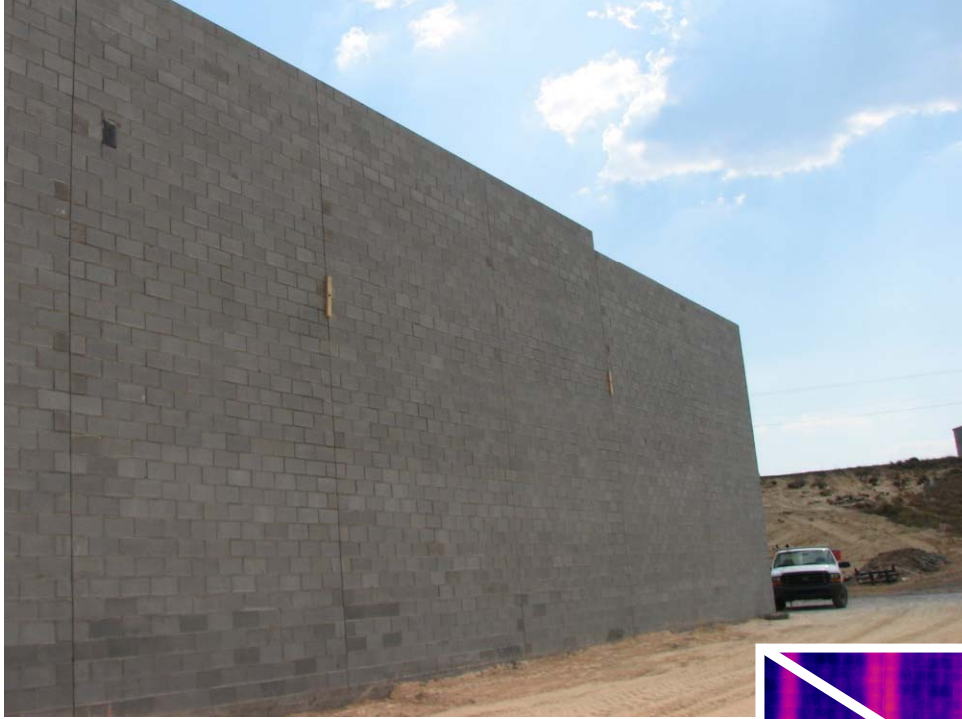
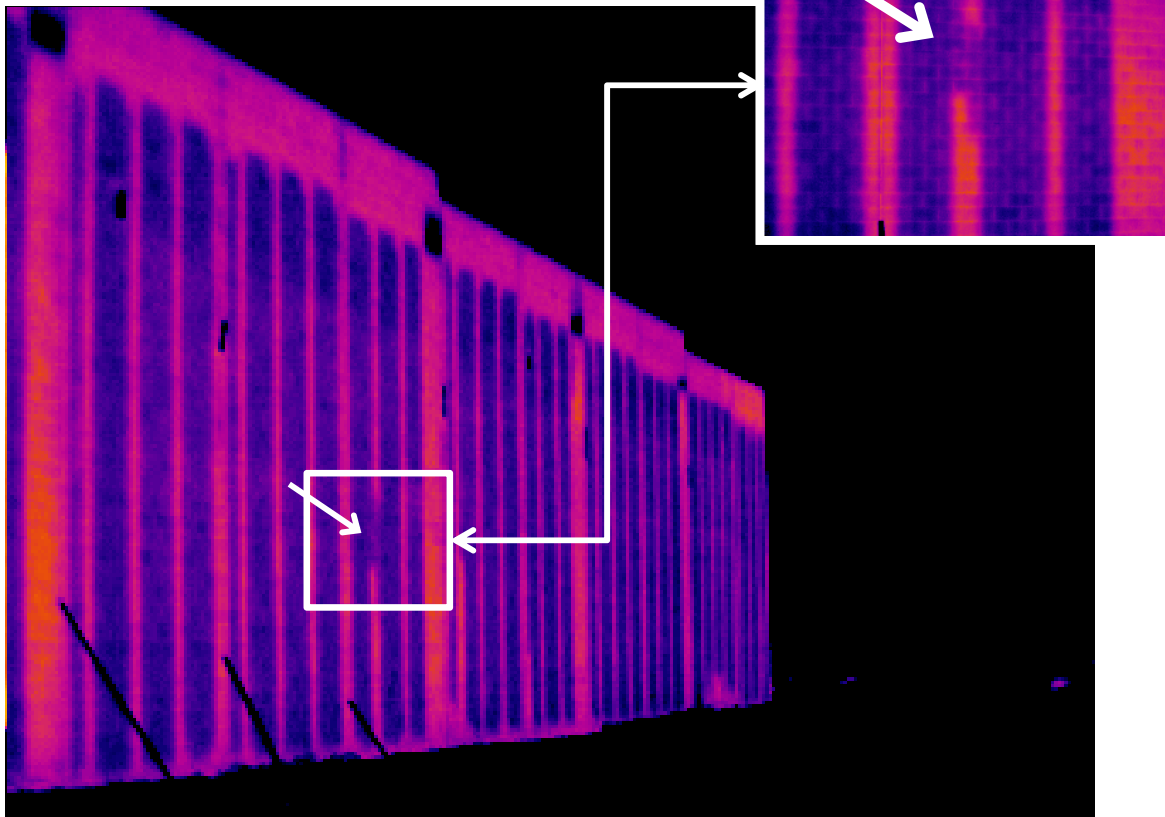
THERMOGRAPHIC REPORT # 6

Down Column Line A
From Column 5 to 6
Description Grouted cells as indicated.

Solid areas are light-colored.

Grouted cells 48" O.C.
Structural Grouting Schedule

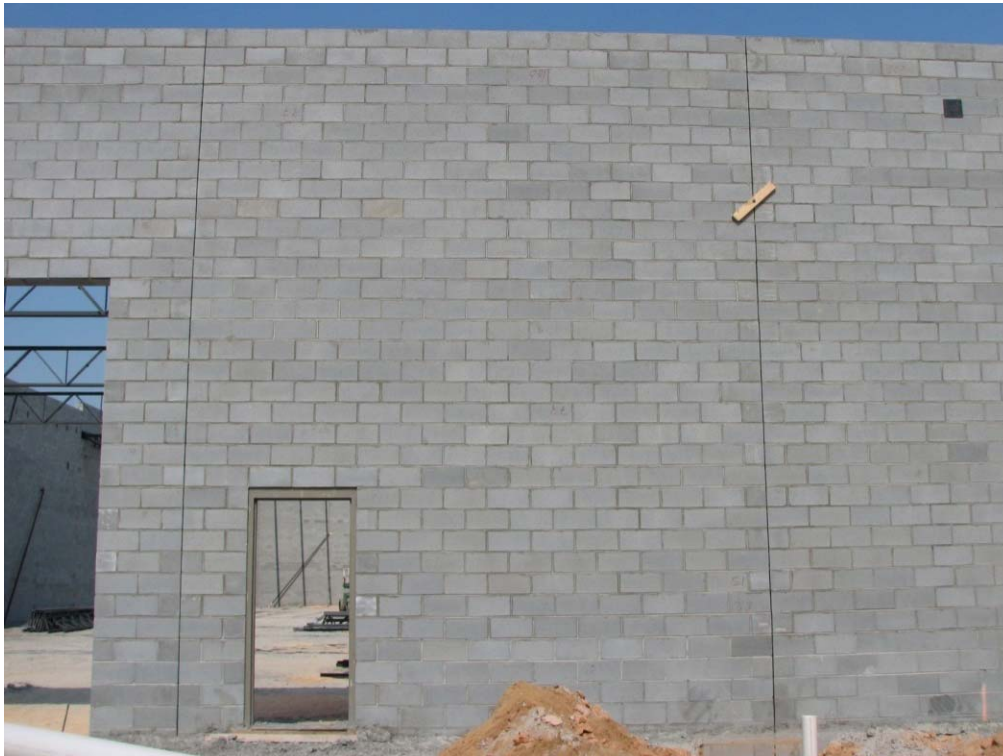
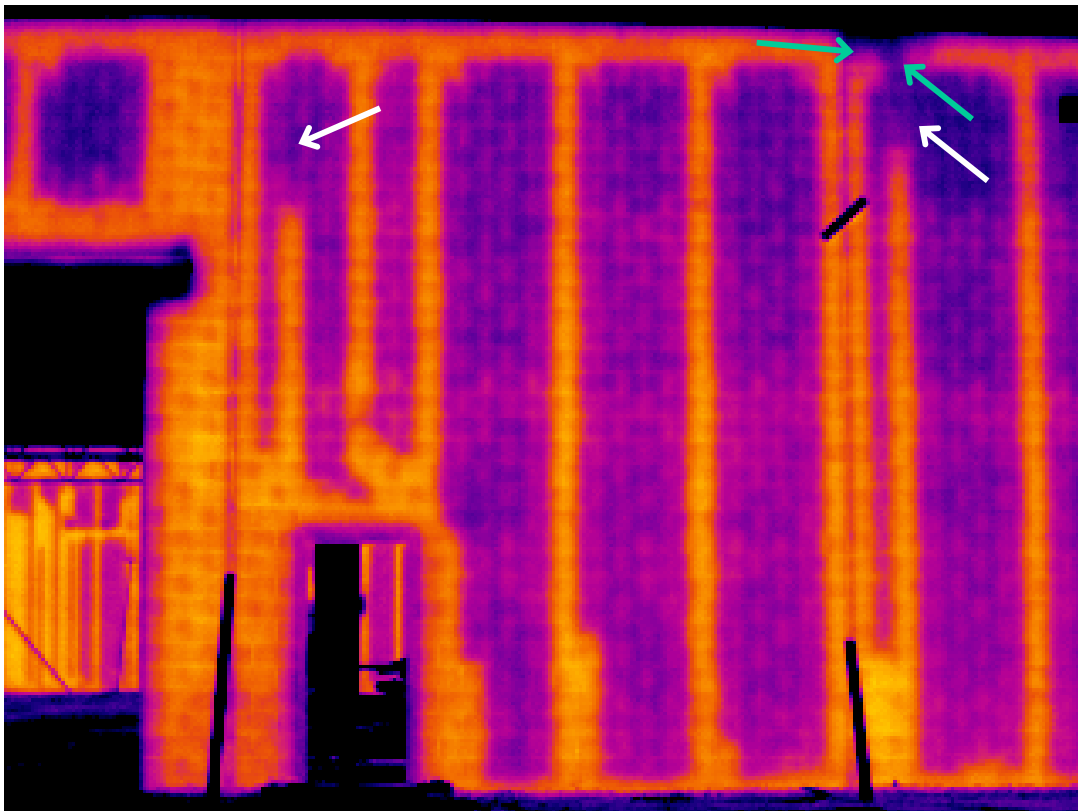
THERMOGRAPHIC REPORT # 7

Down Column Line 9
From Column A.40 to B.10
Description Grouted cells as indicated.

Solid areas are light-colored.
Grouted cells 48" O.C.
Structural Grouting Schedule

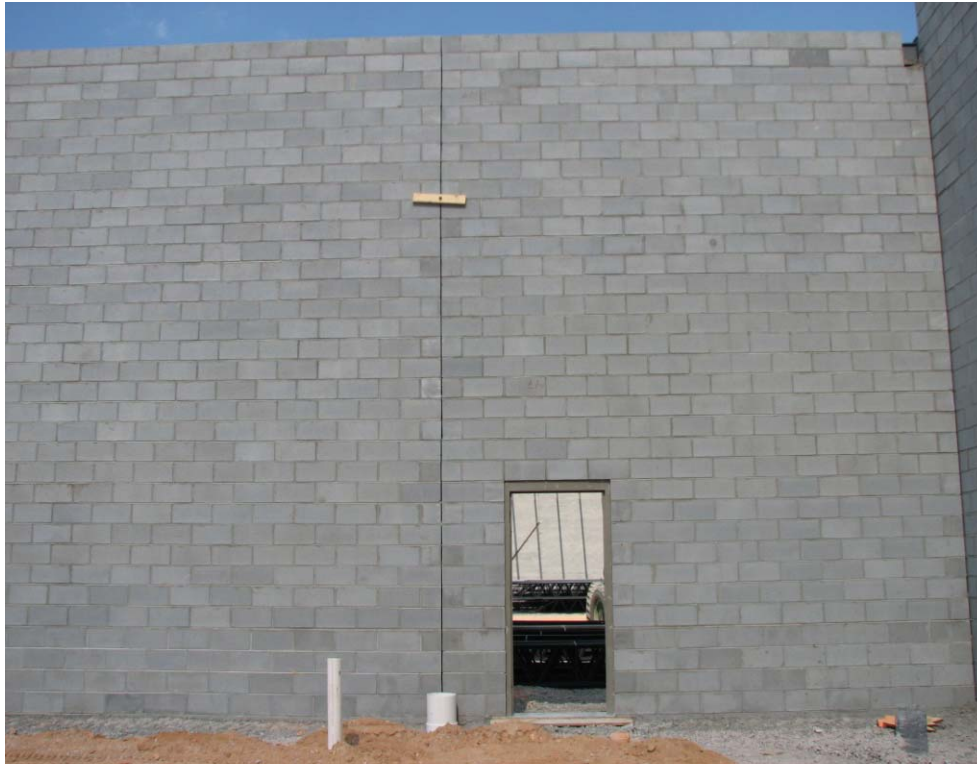
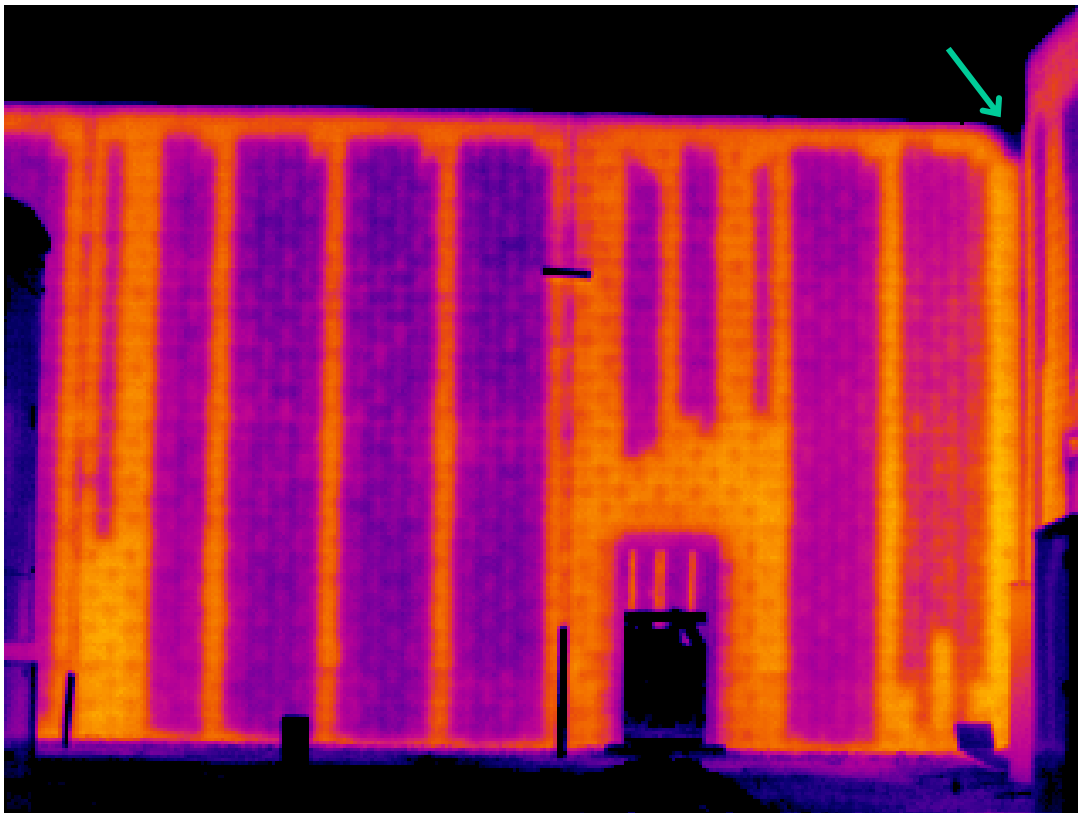
THERMOGRAPHIC REPORT # 8

Down Column Line 9
From Column C to C.29
Description Grouted cells as indicated.

Solid areas are light-colored.
Grouted cells 48" O.C.
Structural Grouting Schedule

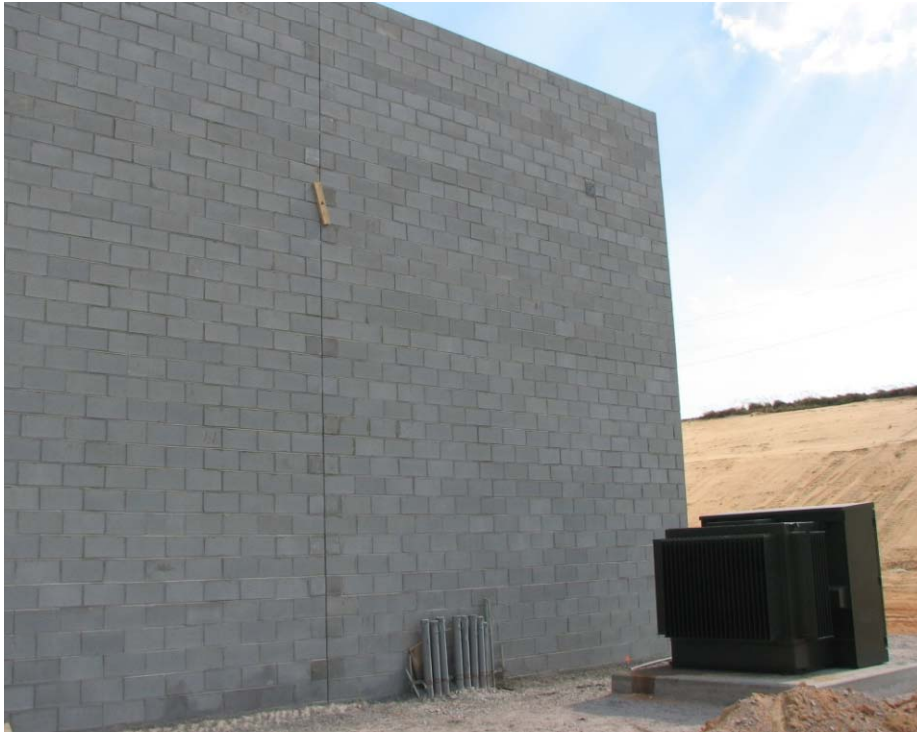
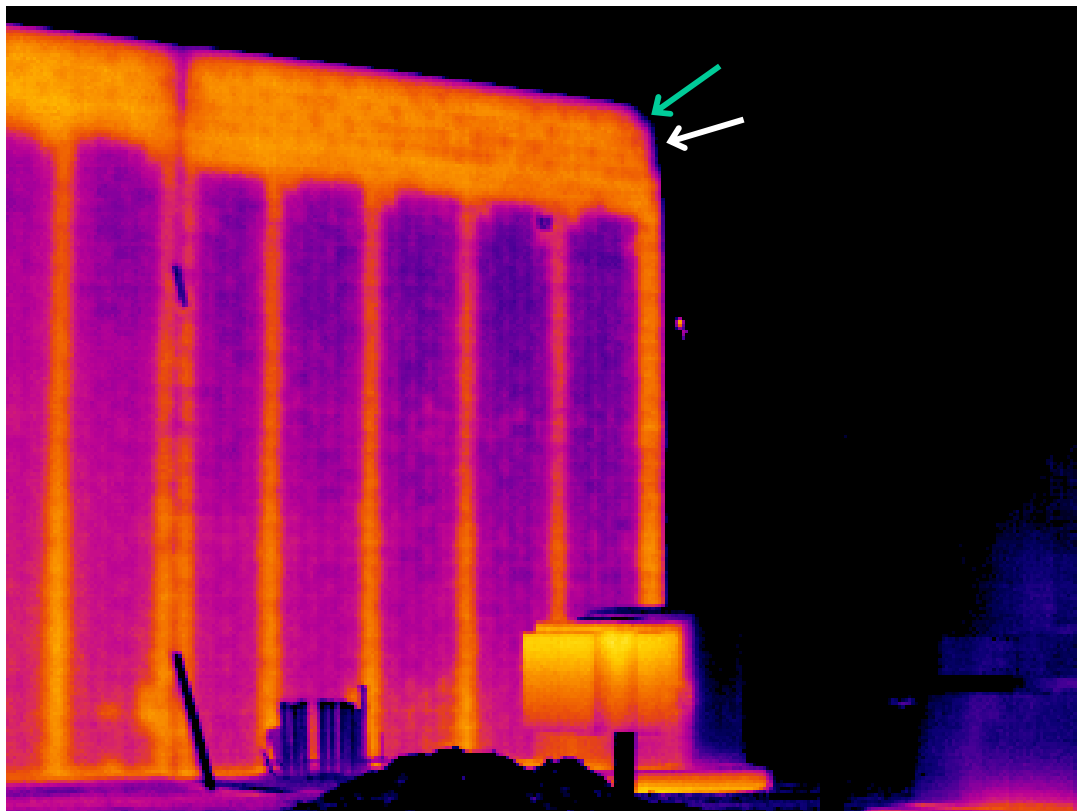
THERMOGRAPHIC REPORT # 9

Down Column Line C.29
From Column 9.22 to 10
Description Grouted cells as indicated.

Solid areas are light-colored.
Grouted cells 48" O.C.
Structural Grouting Schedule

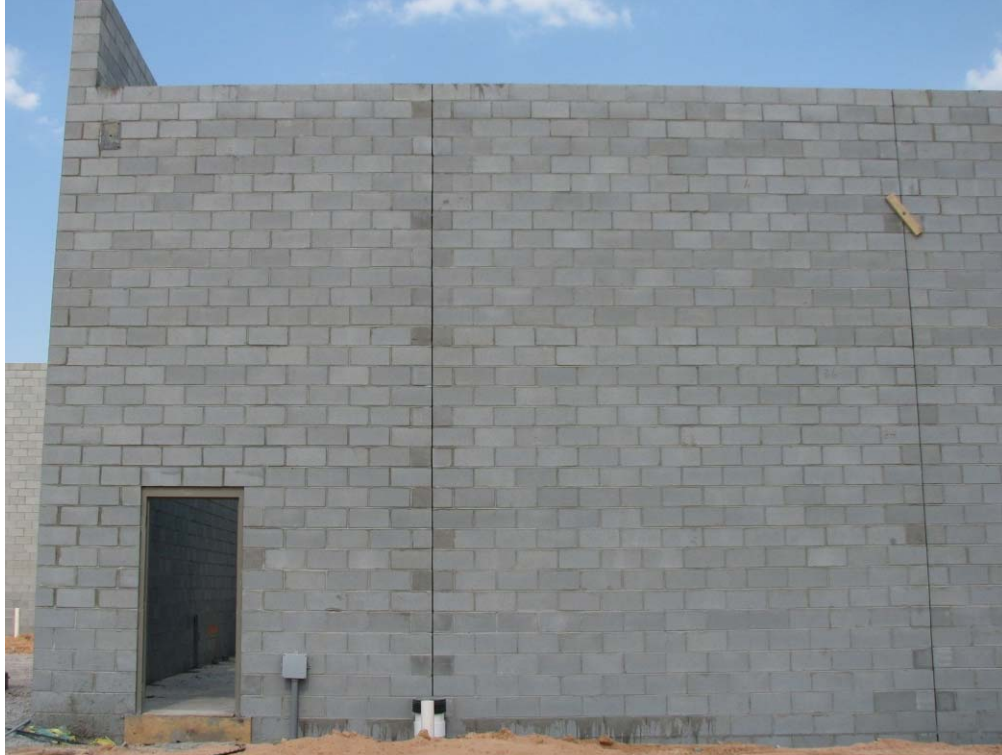
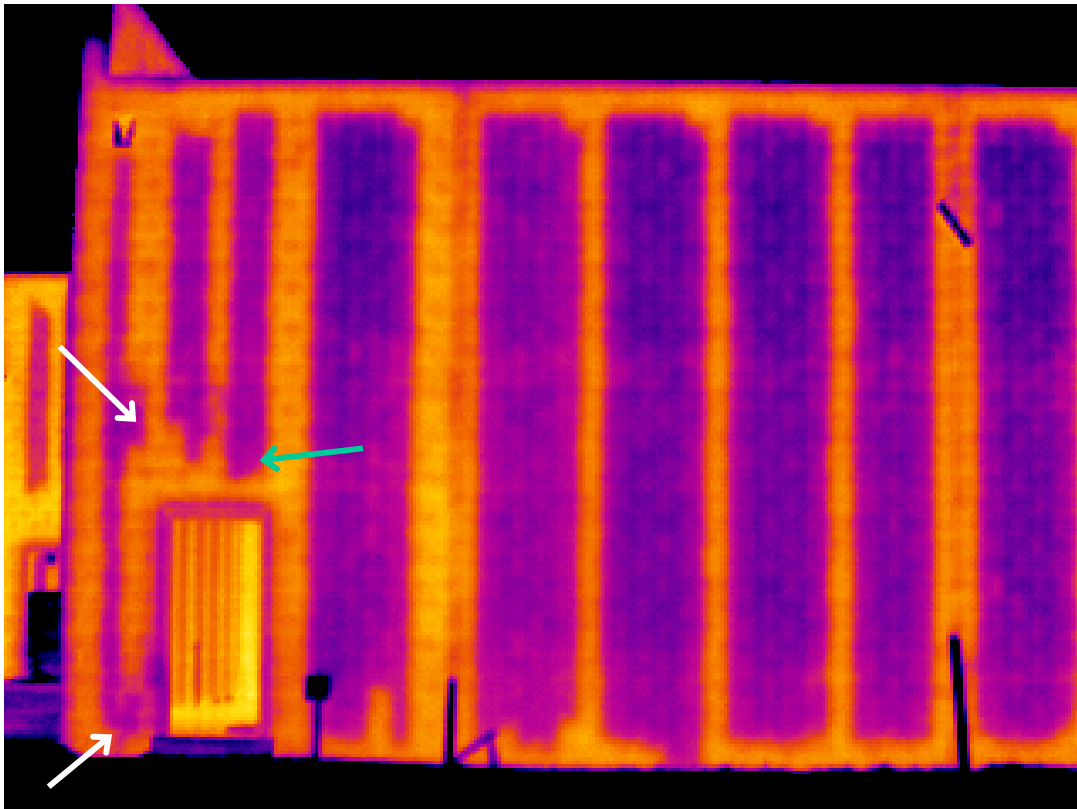
THERMOGRAPHIC REPORT # 10

Down Column Line 10
From Column C.29 to D.23
Description Grouted cells as indicated.

Solid areas are light-colored.
Grouted cells 48" O.C.
Structural Grouting Schedule

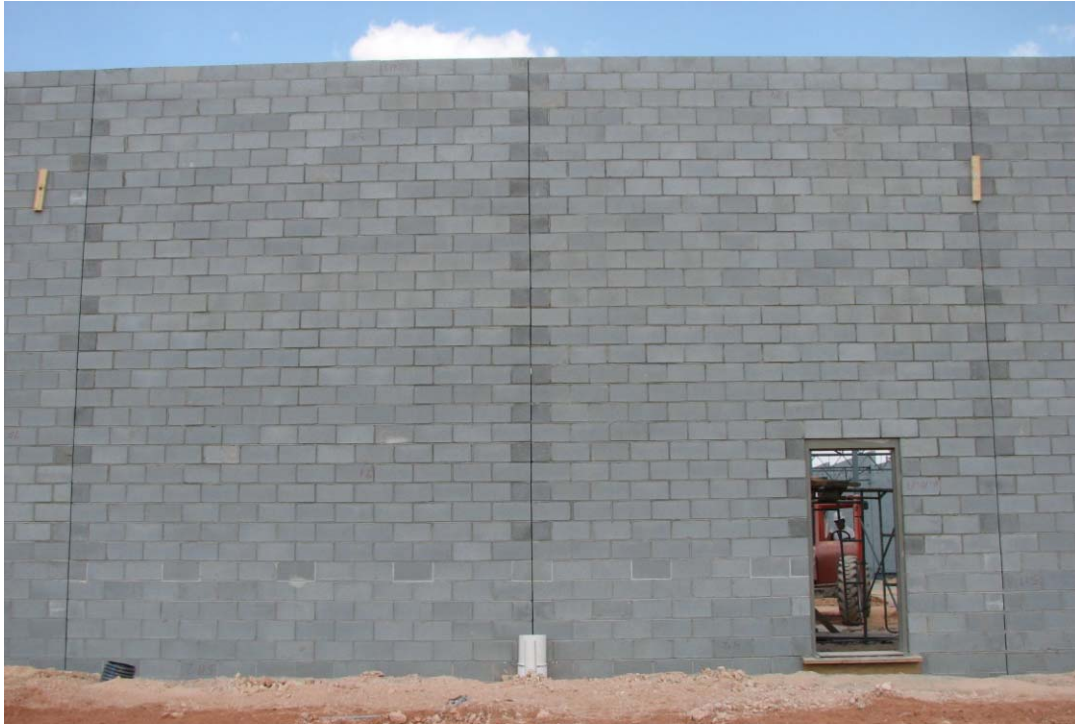
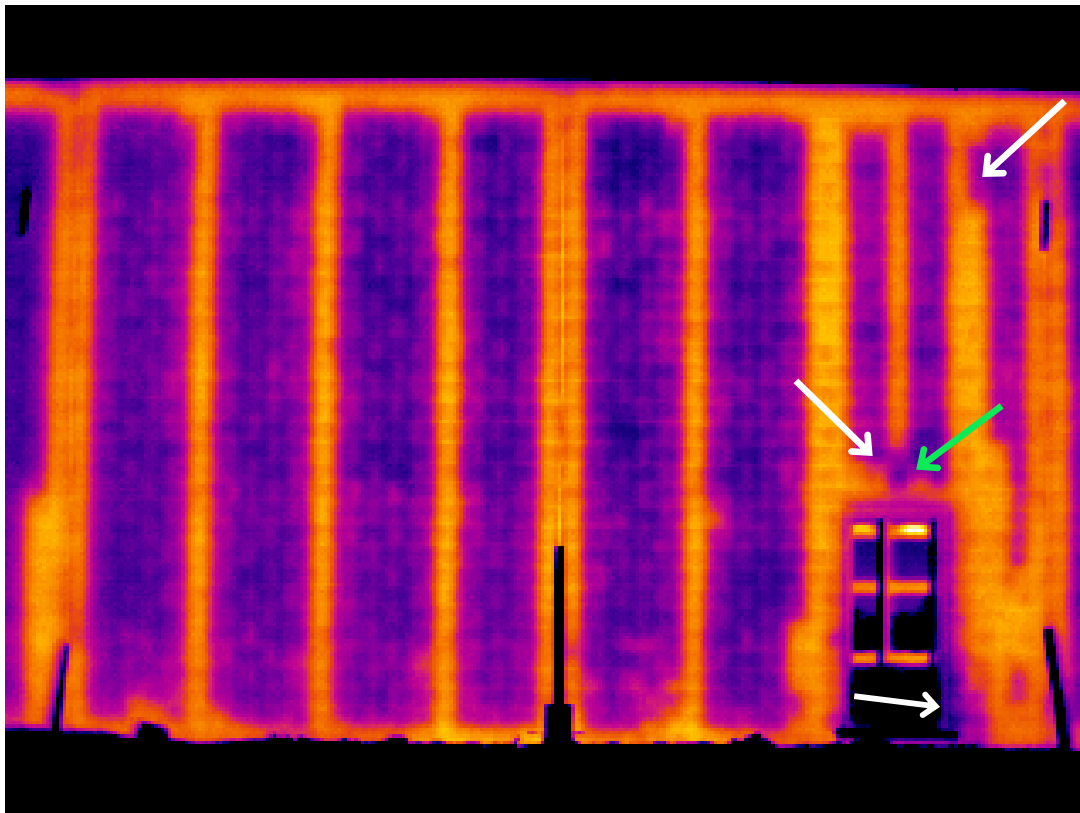
THERMOGRAPHIC REPORT # 11

Down Column Line 10
From Column H to J.05
Description Grouted cells as indicated.

Solid areas are light-colored.
Grouted cells 48" O.C.
Structural Grouting Schedule

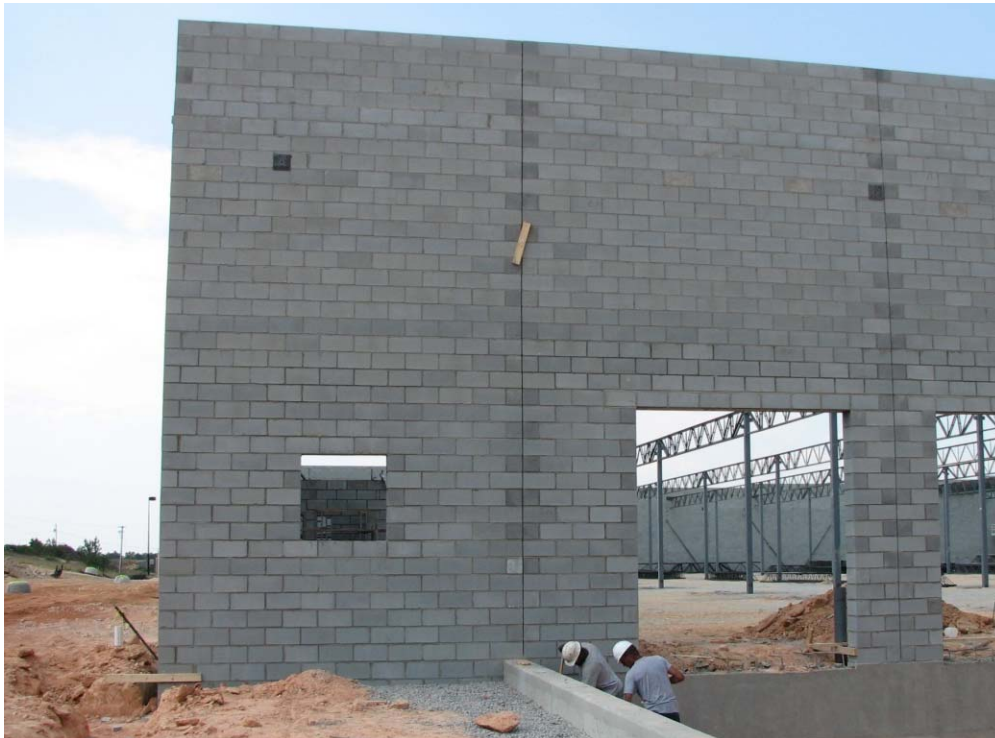
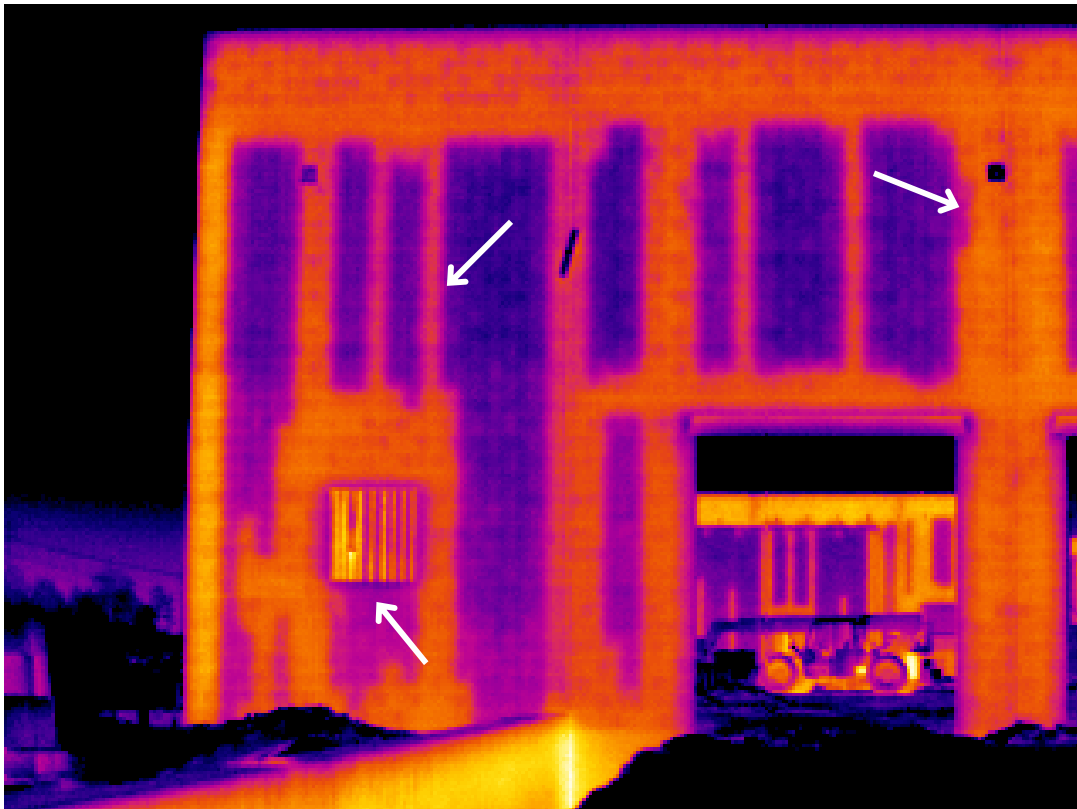
THERMOGRAPHIC REPORT # 12

Down Column Line K
From Column 10 to 9.30
Description Grouted cells as indicated.

Solid areas are light-colored.

Grouted cells 48" O.C.
Structural Grouting Schedule

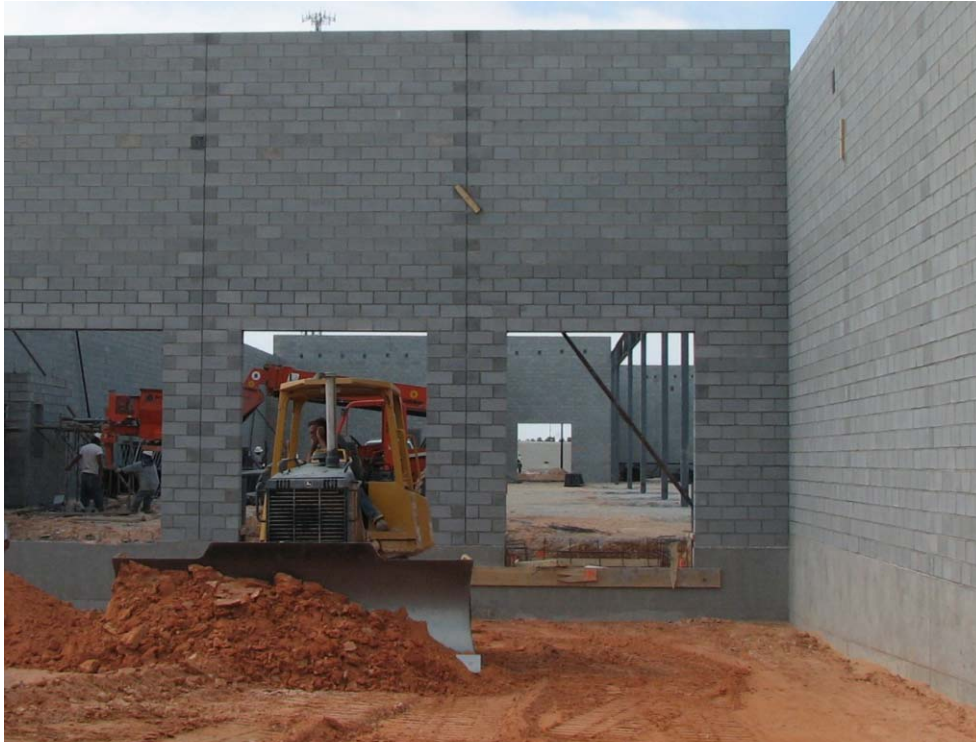
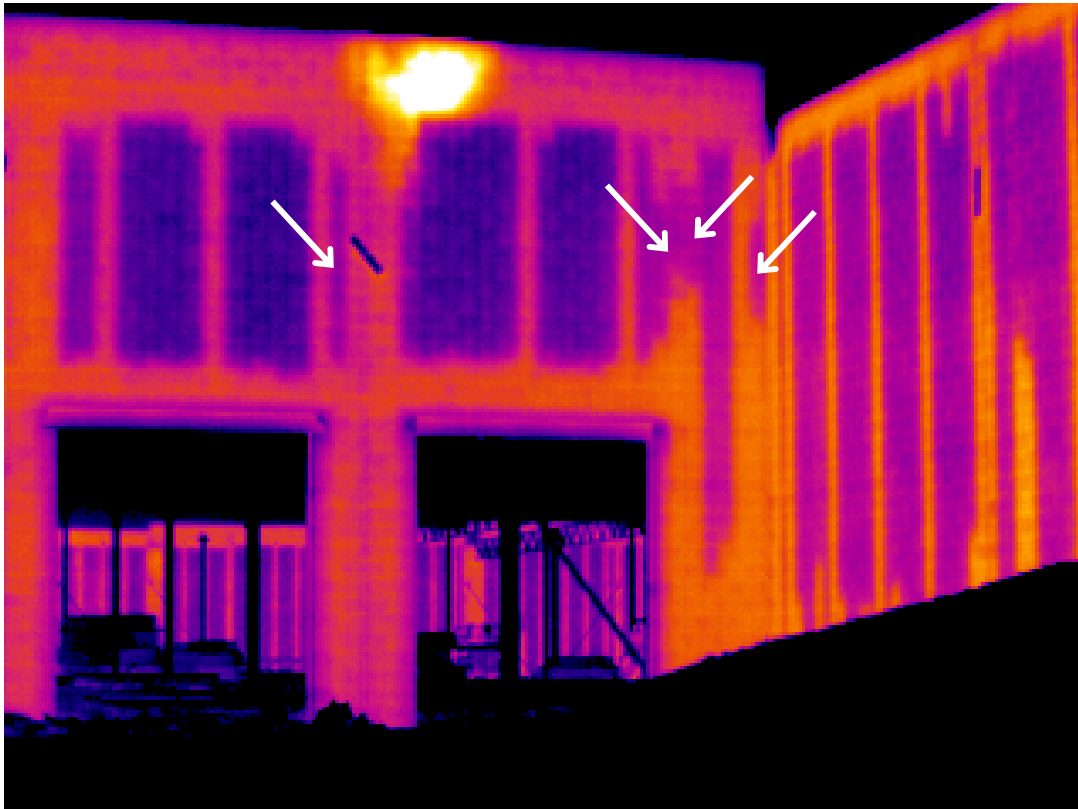
THERMOGRAPHIC REPORT # 13

Down Column Line K
From Column 9.30 to 9
Description Grouted cells as indicated.

Solid areas are light-colored.
Grouted cells 48" O.C.
Structural Grouting Schedule
