Sample Grouted Cell Report

Qualitative Infrared Thermographic Survey of Masonry Walls

Sample Retail Store

**PROJECT: Sample Retail Store
Your Town, USA.**

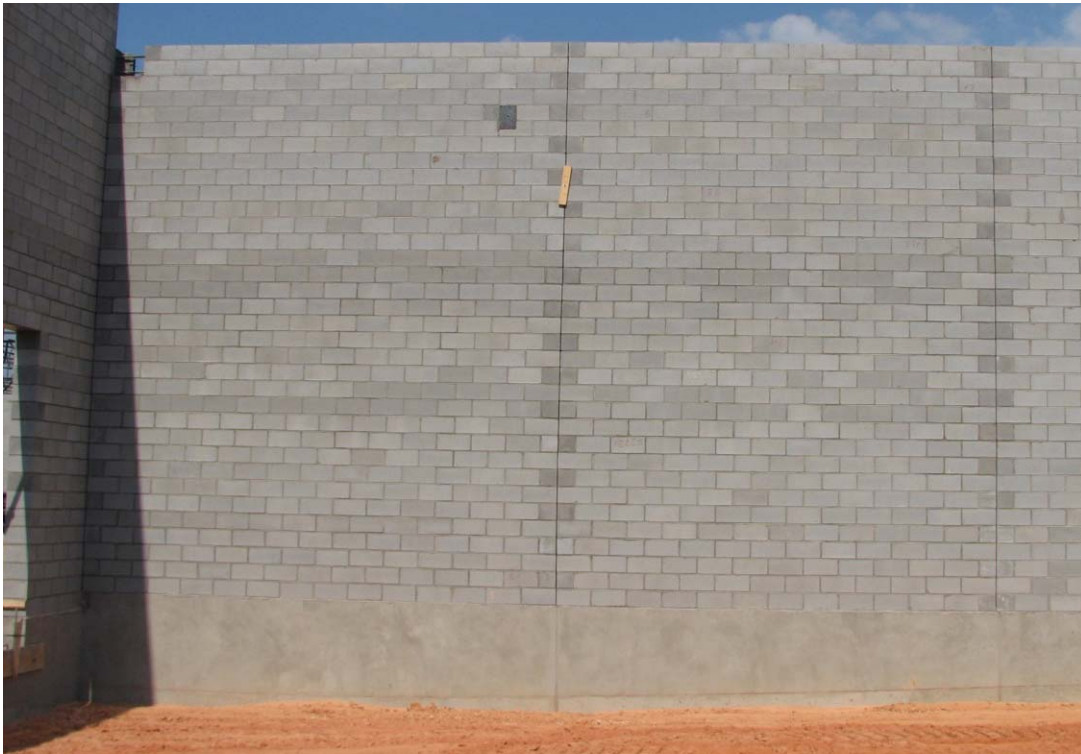
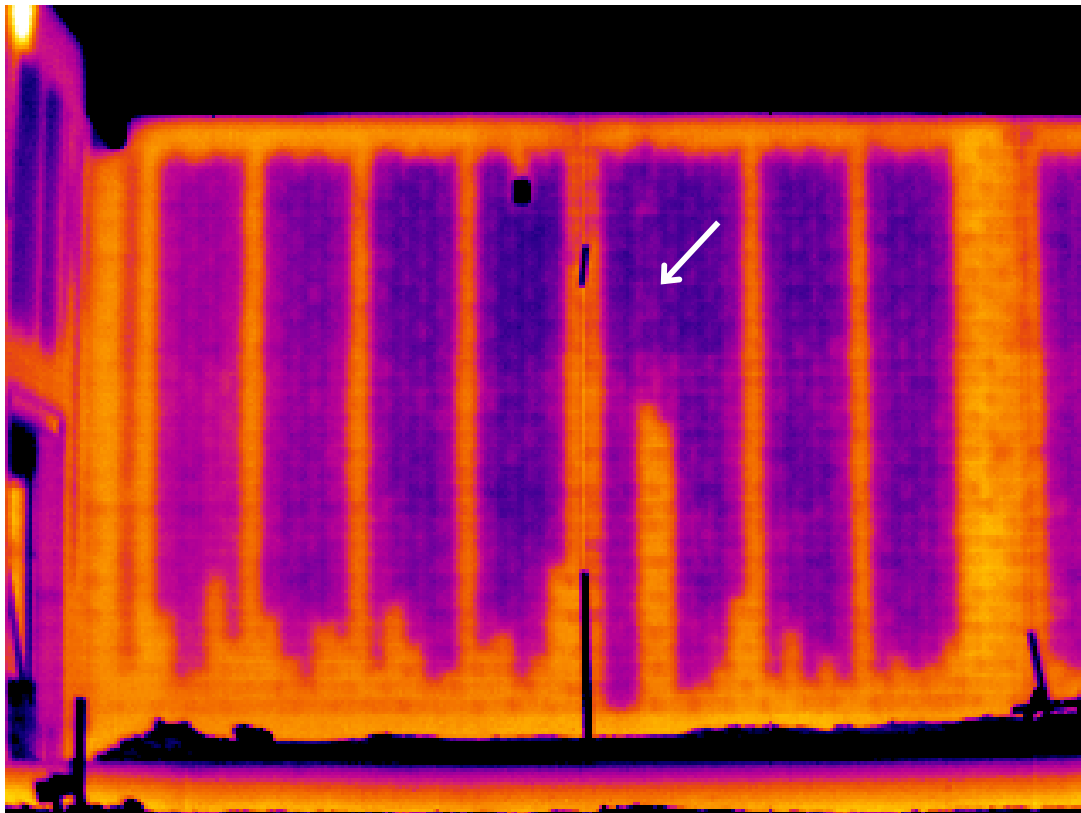
THERMOGRAPHIC REPORT # 14

Down Column Line 9
From Column K to L
Description Grouted cells as indicated.

Solid areas are light-colored.
Grouted cells 48" O.C.
Structural Grouting Schedule

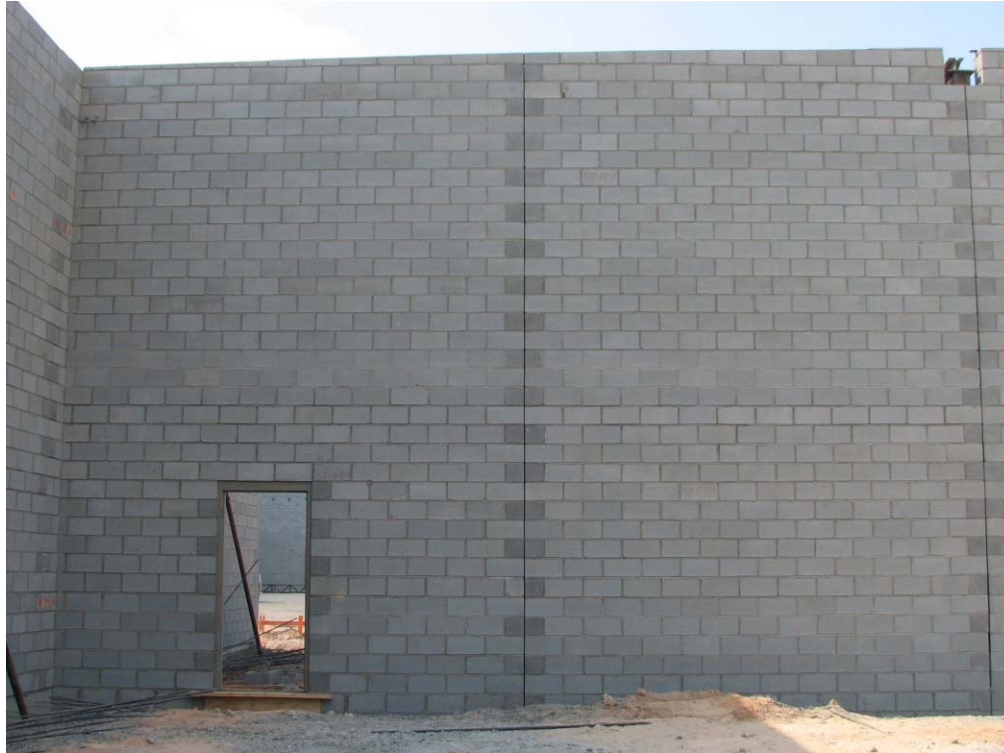
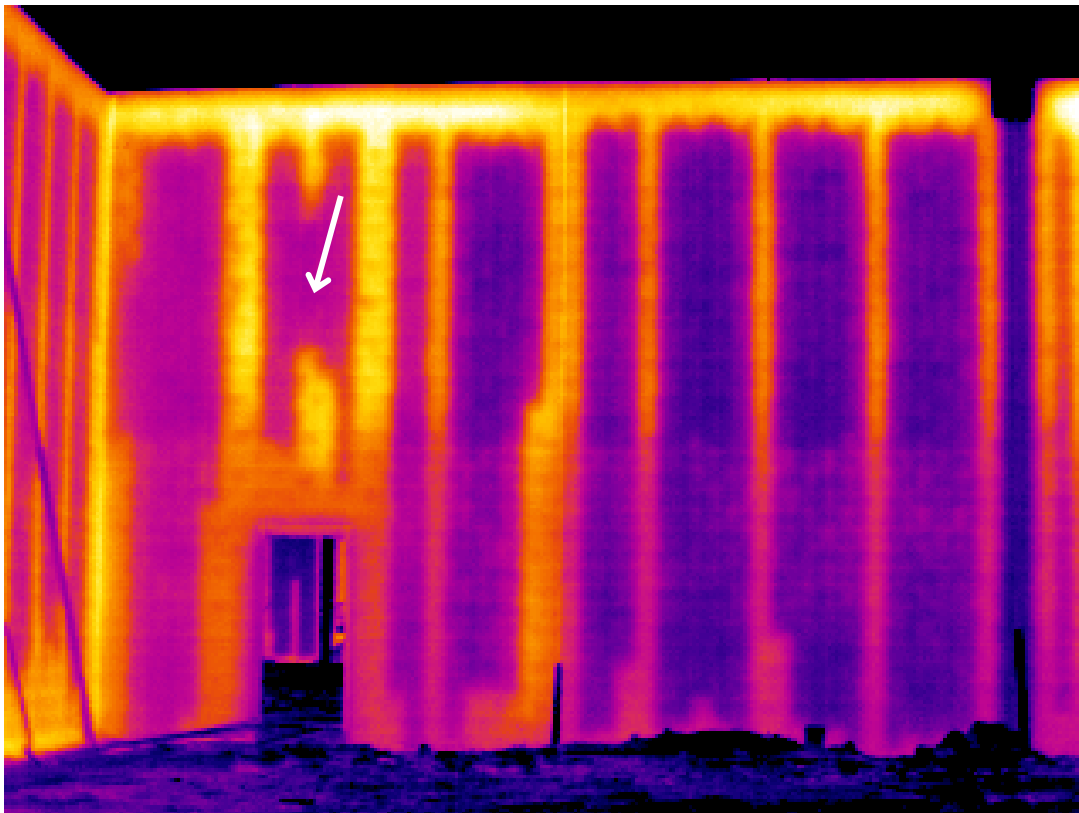
THERMOGRAPHIC REPORT # 15

Down Column Line L
From Column 9 to 8
Description Grouted cells as indicated.

Solid areas are light-colored.
Grouted cells 48" O.C.
Structural Grouting Schedule

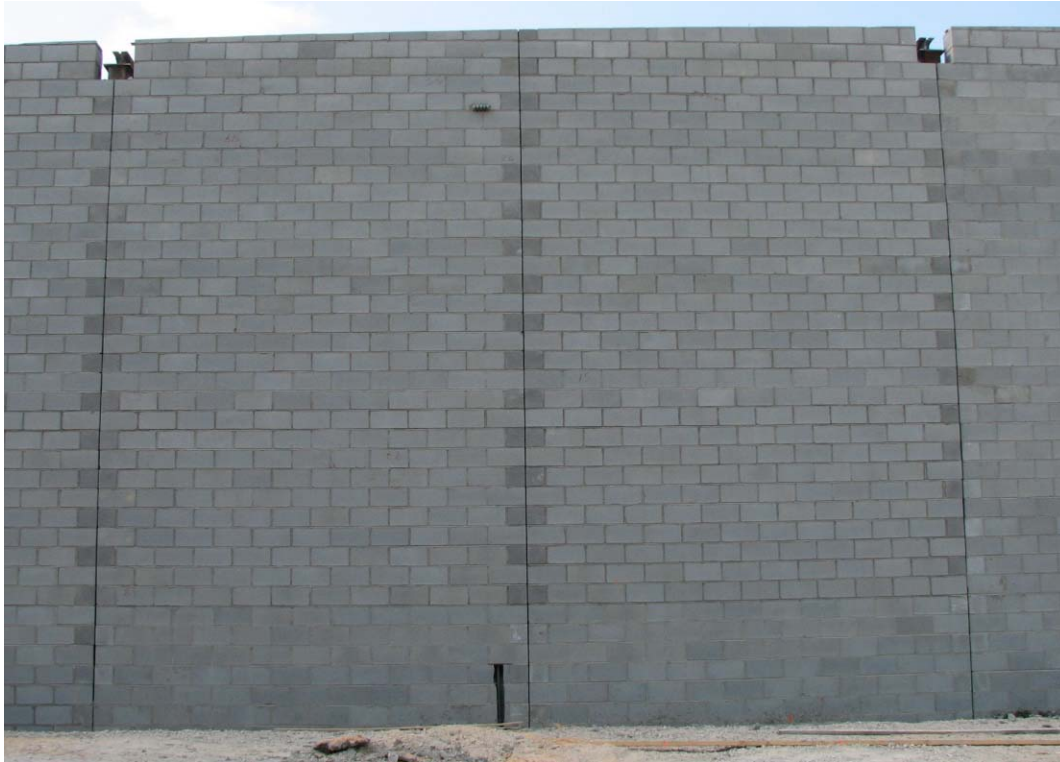
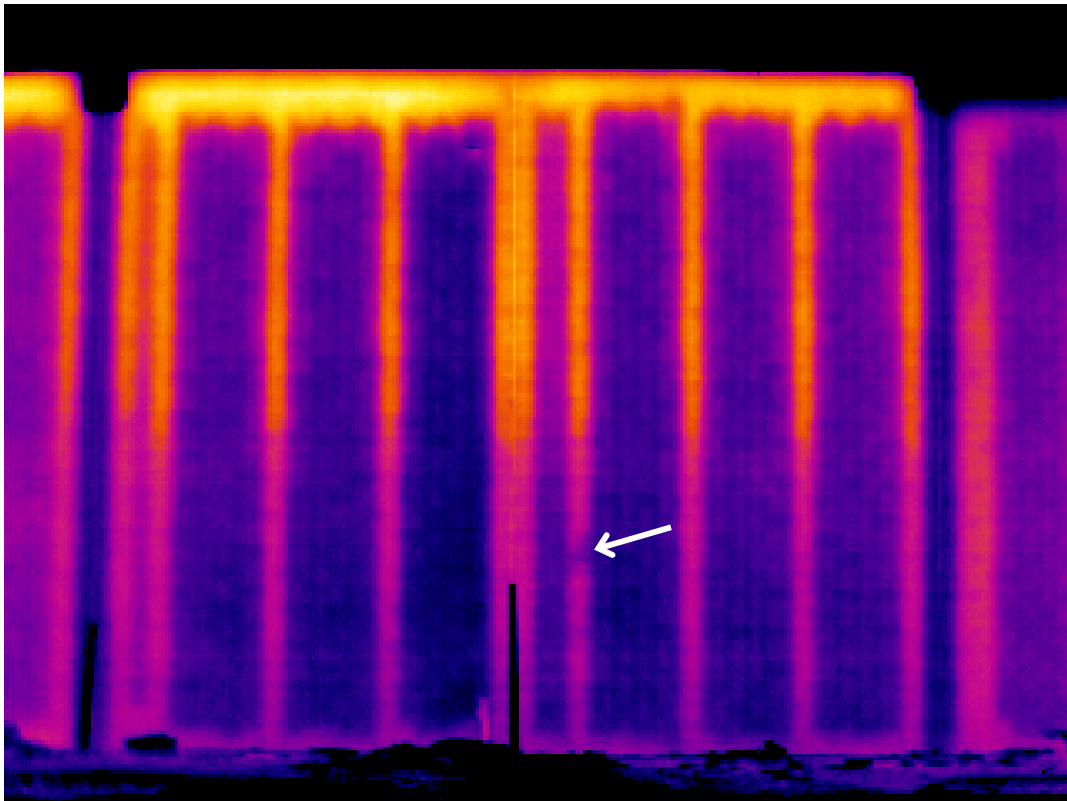
THERMOGRAPHIC REPORT # 16

Down Column Line L
From Column 8 to 7
Description Grouted cells as indicated.

Solid areas are light-colored.
Grouted cells 48" O.C.
Structural Grouting Schedule

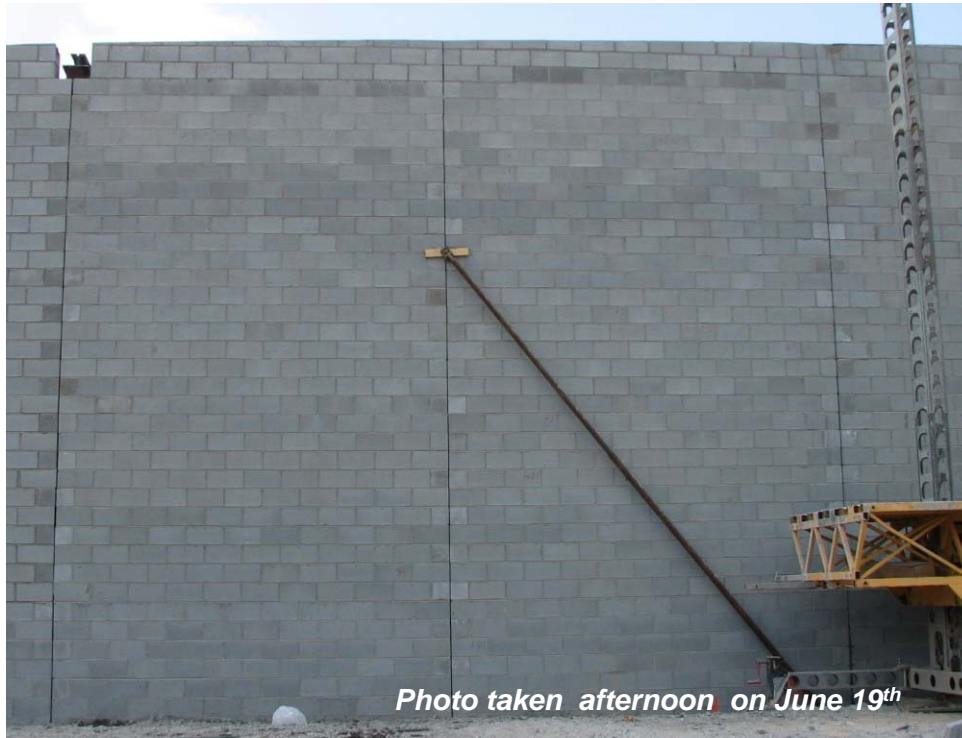
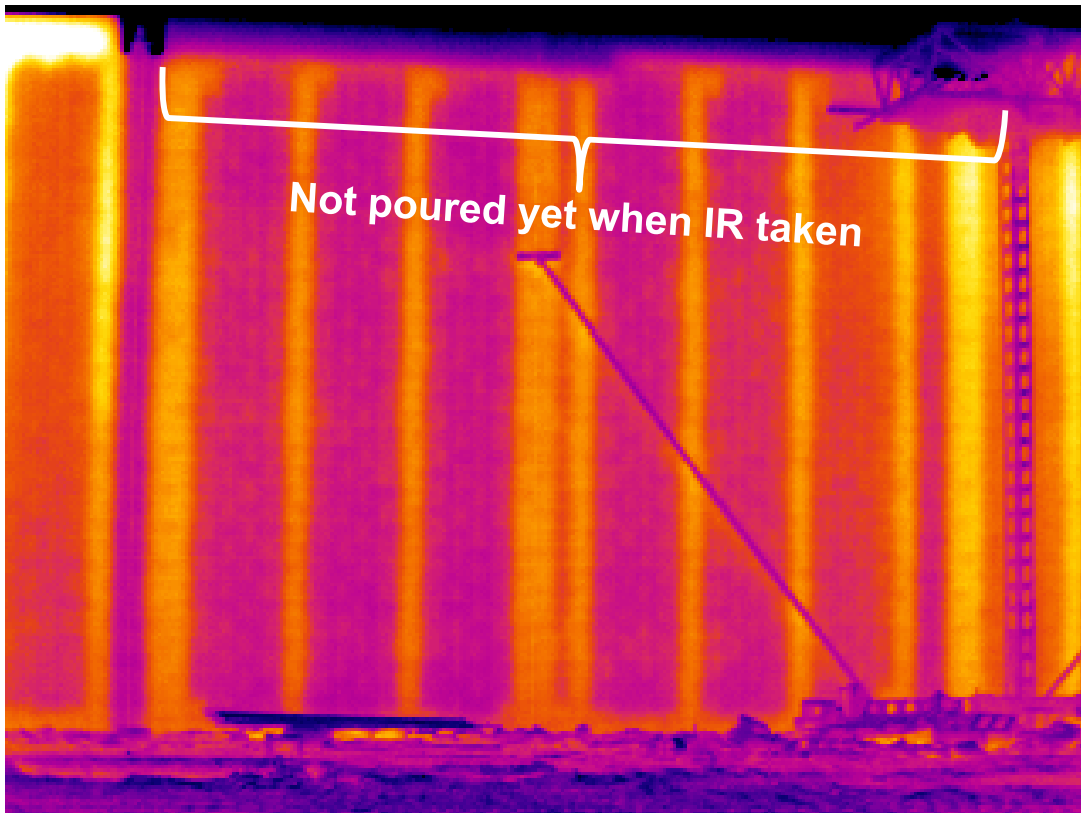
THERMOGRAPHIC REPORT # 17

Down Column Line L

From Column 7 to 6

Description Bond Beams not poured, on Wall L, from 7 to 4.

Solid areas are light-colored.

Grouted cells 48" O.C.
Structural Grouting Schedule

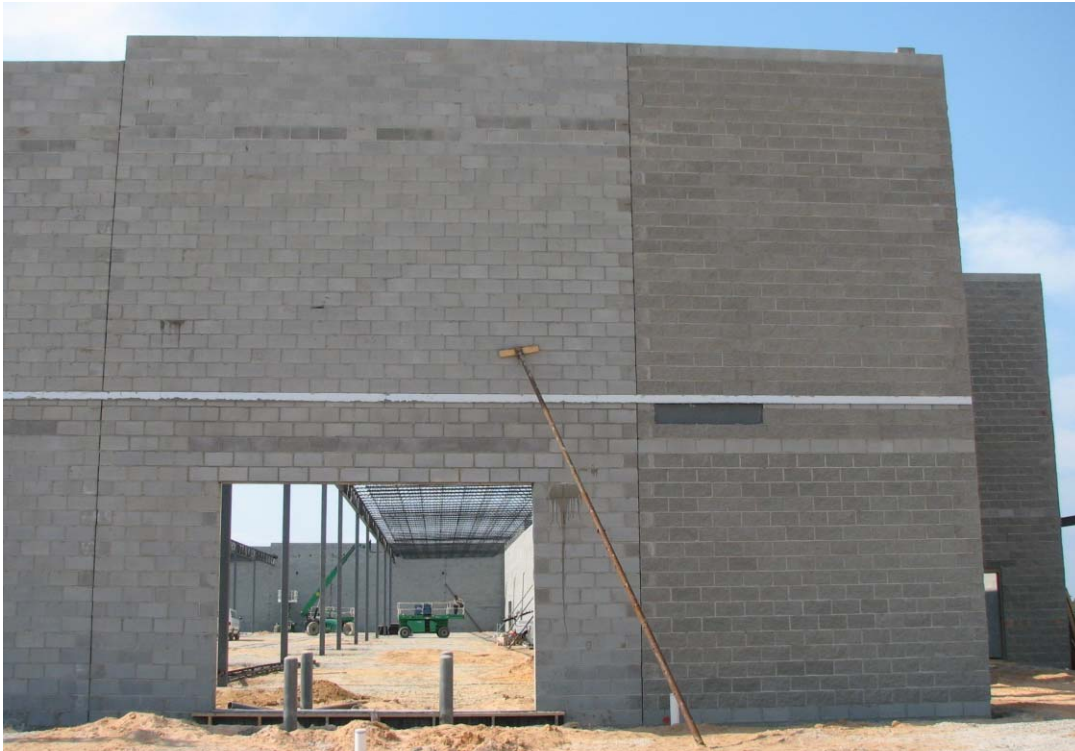
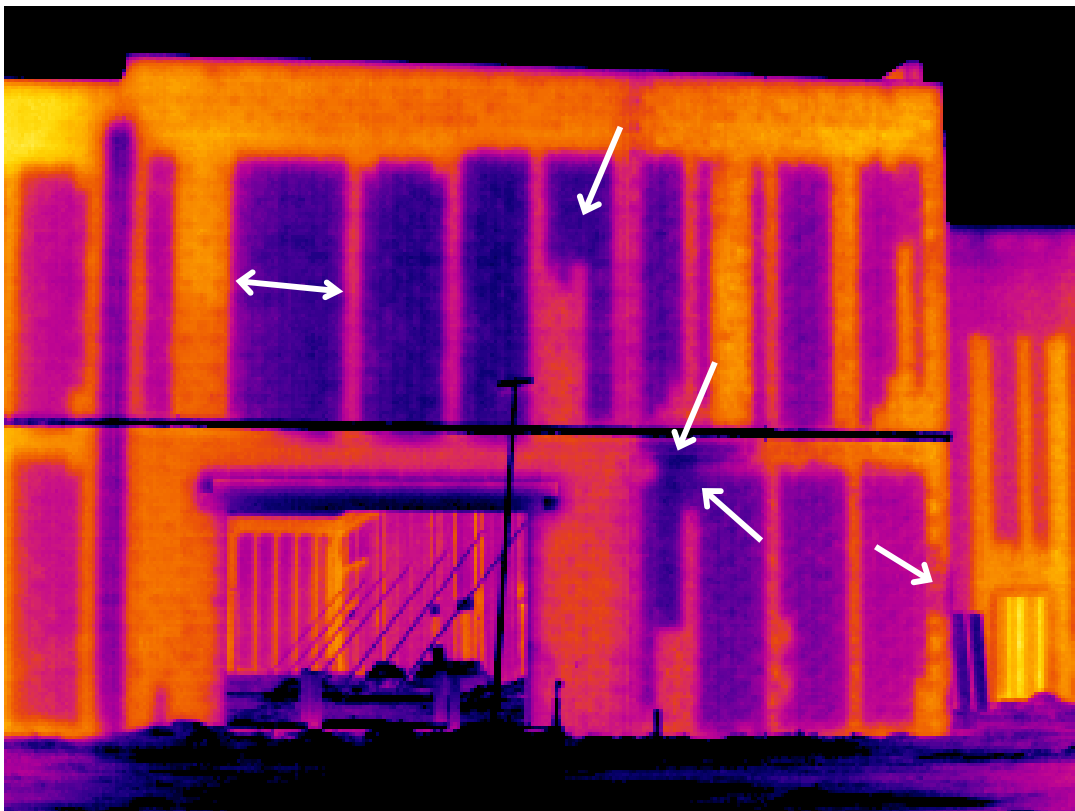
THERMOGRAPHIC REPORT # 18

Down Column Line L
From Column 3 to 2
Description Grouted cells as indicated.

Solid areas are light-colored.
Grouted cells 48" O.C.
Structural Grouting Schedule

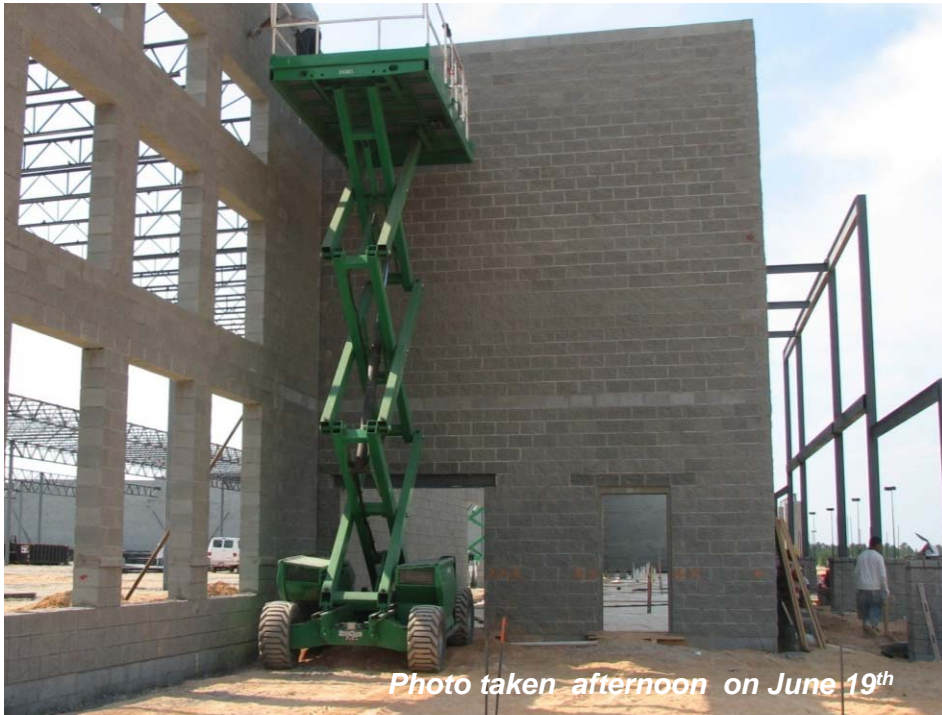
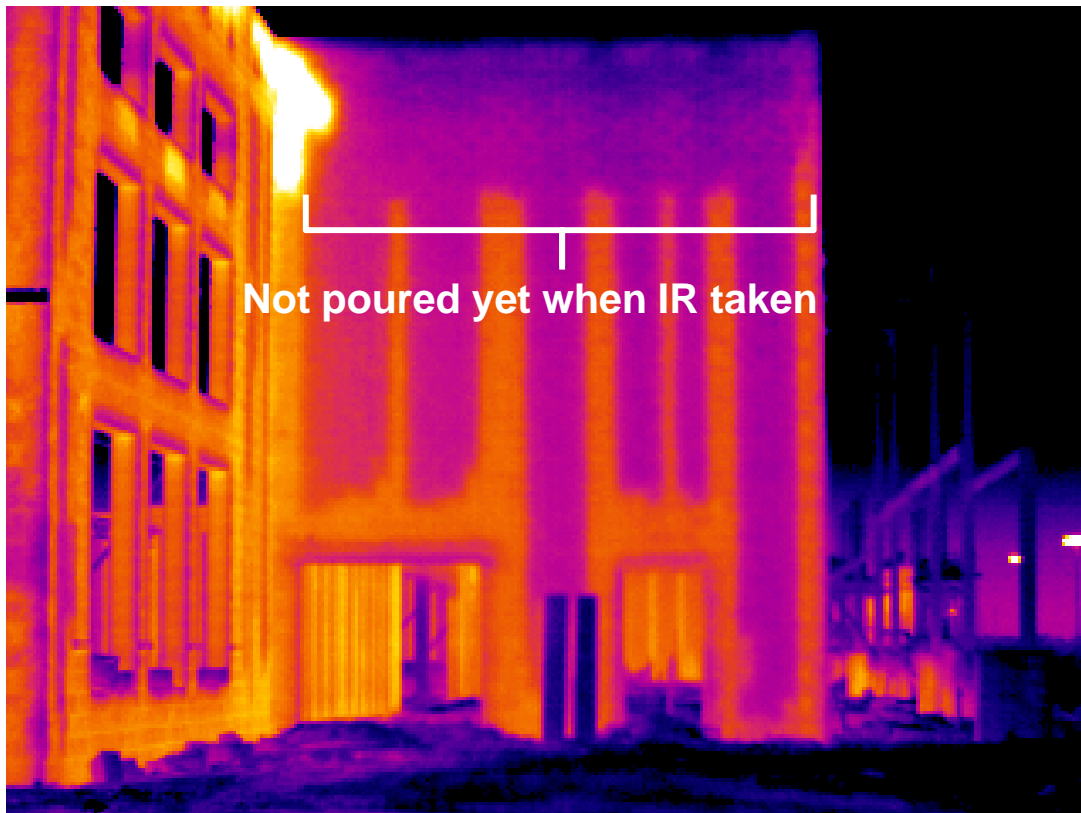
THERMOGRAPHIC REPORT # 19

Down Column Line J.30

From Column 2 to 1

Description Grouted cells as indicated.

Solid areas are light-colored.

**Grouted cells 48" O.C.
Structural Grouting Schedule**

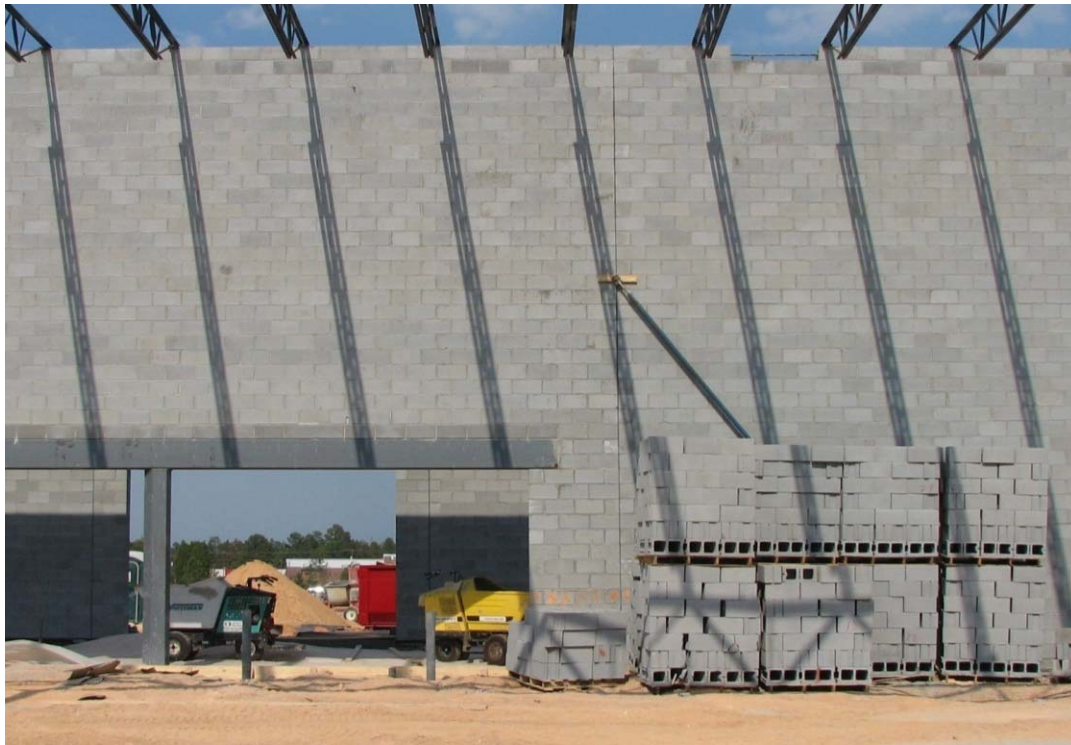
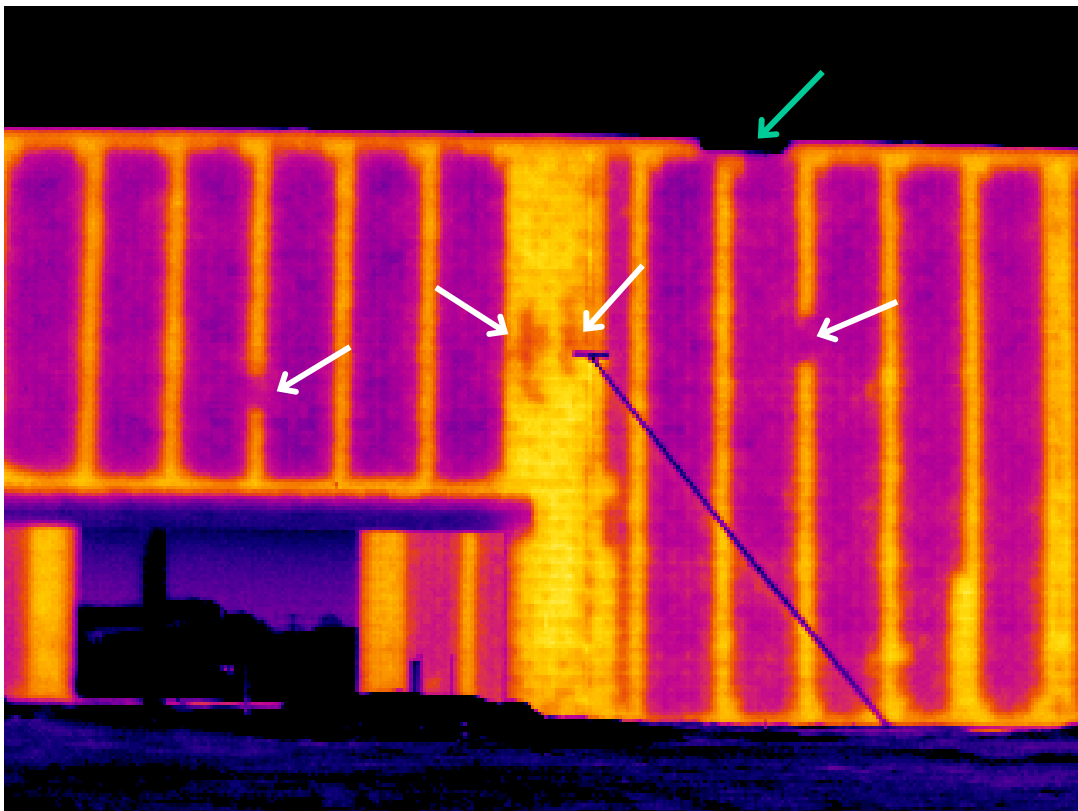
THERMOGRAPHIC REPORT # 20

Down Column Line 2
From Column H to J
Description Grouted cells as indicated.

Solid areas are light-colored.
Grouted cells 48" O.C.
Structural Grouting Schedule
